NASA Contractor Report 159231

# Flight Service Evaluation of Kevlar-49 Epoxy Composite Panels in Wide-bodied Commercial Transport Aircraft

# Sixth Annual Flight Service Report

LOCKHEED-CALIFORNIA COMPANY  
BURBANK, CALIFORNIA

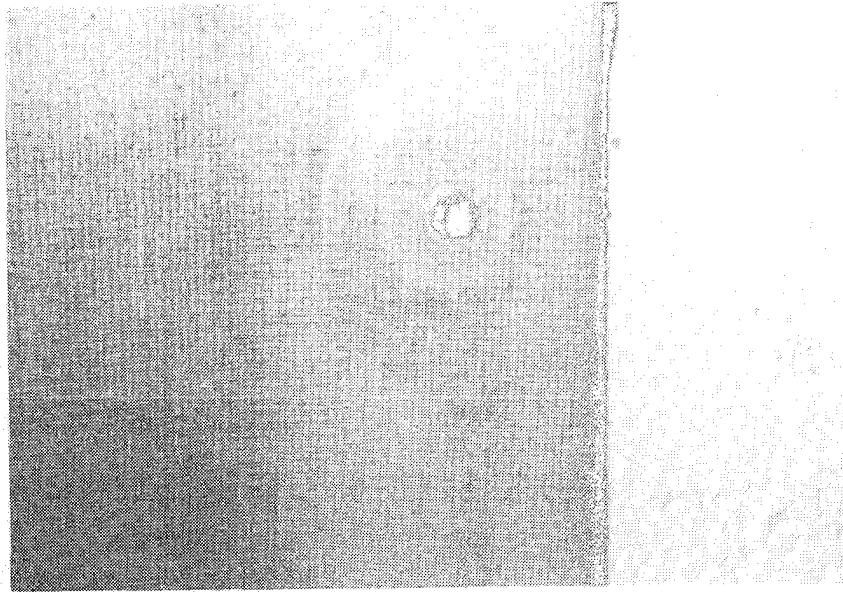
Figure 6. - Air Canada right-hand wing-body fairing - typical fastener hole.

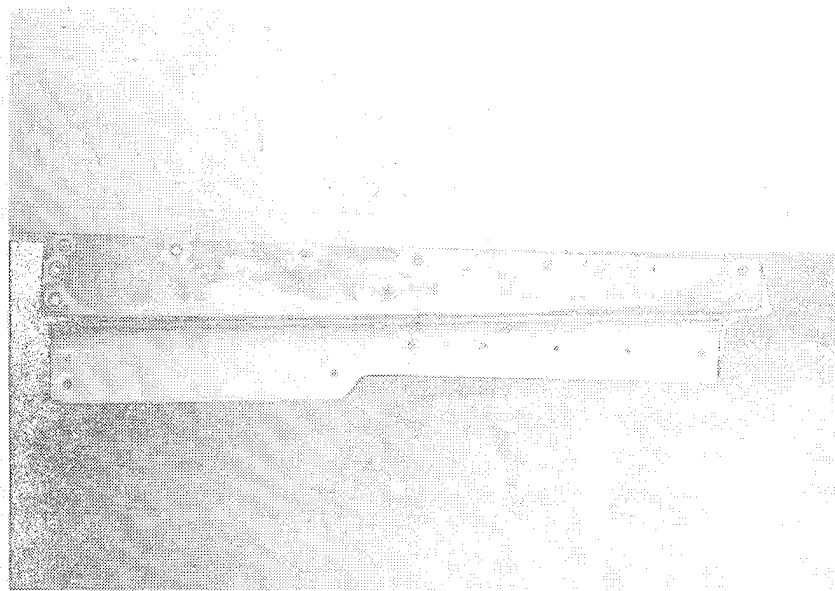
1. No surface damage or defects were noted on either surface although there was considerable paint loss with exposed Kevlar-49. (Figure 9). The location of the exposed Kevlar-49 is such that very little ultraviolet exposure can occur.
2. Fraying was noted on most of the fastener holes, (Figure 10), with four holes more frayed than the others. About half the holes had a significant degree of elongation, with seven holes elongated to 0.55 cm (7/32 in.) maximum dimension from the original 0.5 cm (3/16 in.) diameter, and two holes elongated to 0.6 cm (1/4 in.). There was no correlation between the frayed and elongated holes.

Figure 9. - Air Canada right-hand underwing fillet - exterior  
surface showing paint loss and exposed Kevlar-49.

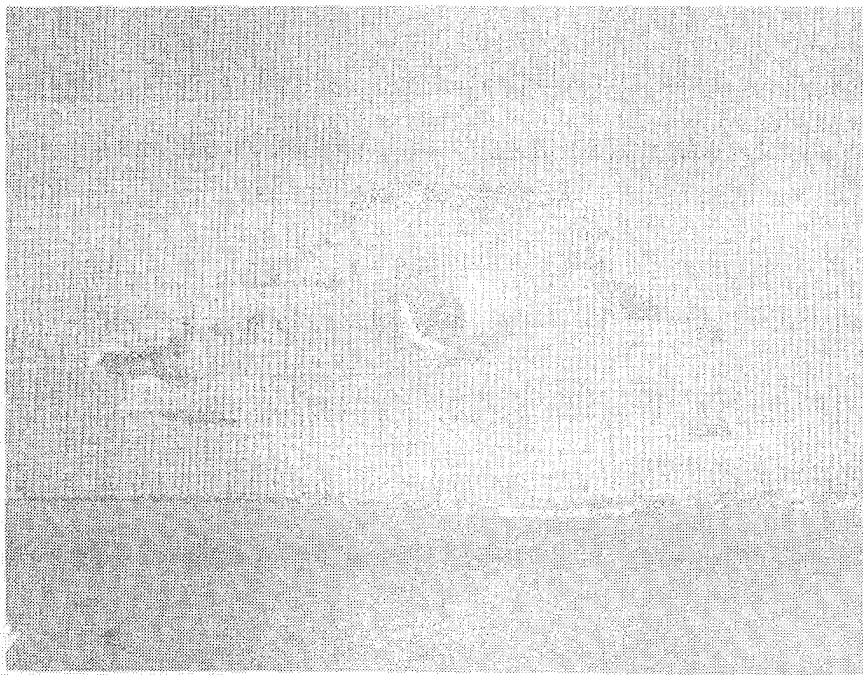
5. Slight fraying was observed on all the fastener holes. All holes on the lower edges had slight elongation and noticeable mark-off of the washers, with a convex deformation of the laminate around the holes. (Figure 13). Several holes on the other edges were slightly elongated. Two holes on the top edge at the forward end were badly frayed and elongated to a 0.6 cm ( $\frac{1}{4}$  in.) maximum dimension. (Figure 14).

Figure 13. - Eastern left-hand wing-body fairing - fastener  
hole on lower edge with mark-off.

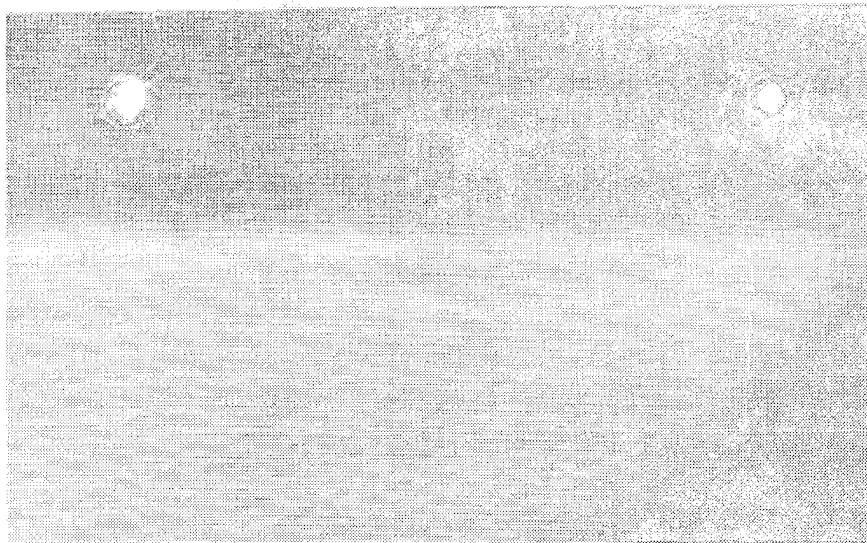
Figure 14. - Eastern left-hand wing-body fairing - frayed and elongated holes on top edge.

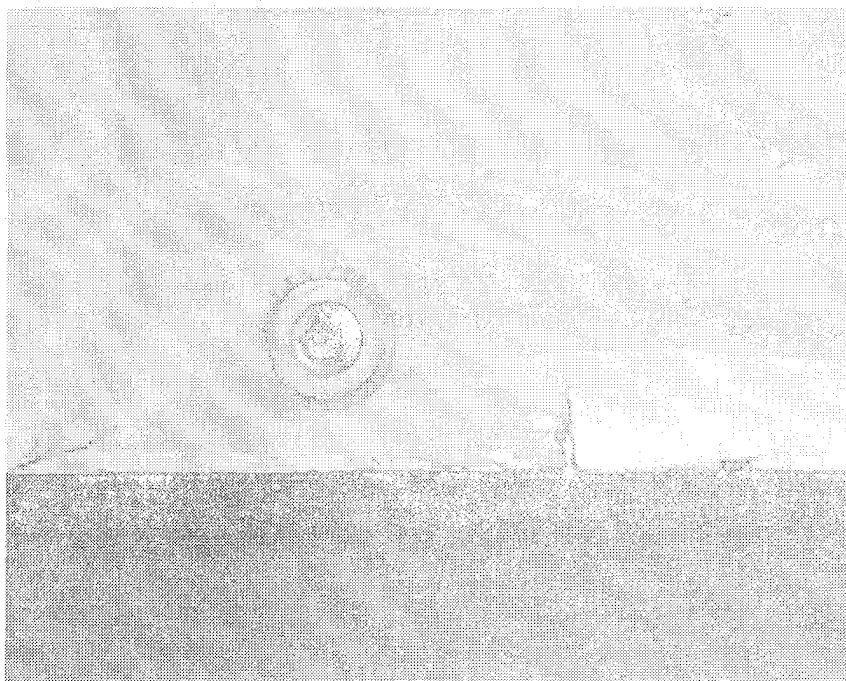
1. Several exterior surface cracks observed in previous inspections had not propagated or changed in appearance:
  - A 1.3 cm ( $\frac{1}{2}$  in.) crack in the forward edge between the fifth and sixth holes from the top. (Figure 15).

Figure 15. - Eastern right-hand wing-body fairing - crack in forward edge.

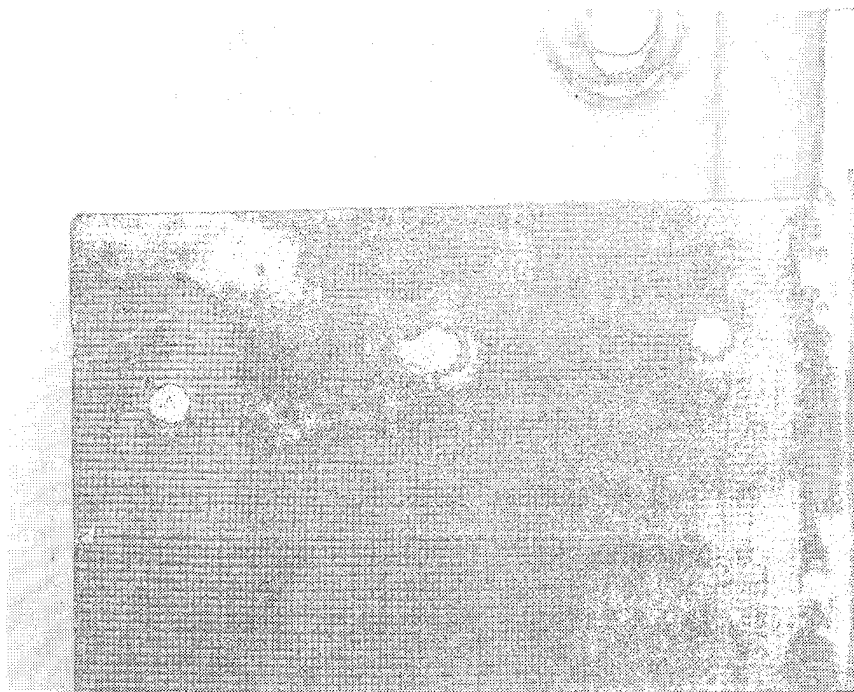
Figure 18. - Eastern right-hand underwing fillet - frayed and elongated holes from inner surface.

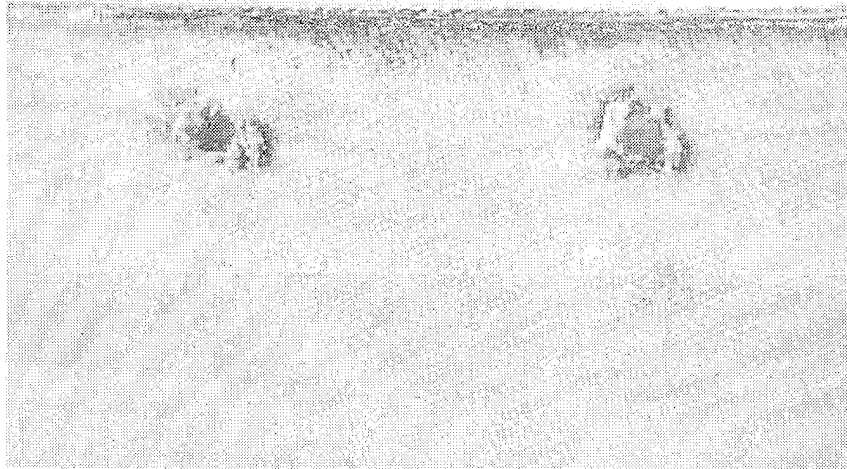
2. Fraying was observed on all fastener holes. This fraying was more severe than on the wing-body fairing and under-wing fillet panels. (Figure 20). The intercostal holes were less frayed than the holes in the solid laminate edge member. Slight elongation was observed on about 10% of the holes.

Figure 20. - Eastern left-hand aft engine fairing - fastener holes with severe fraying.

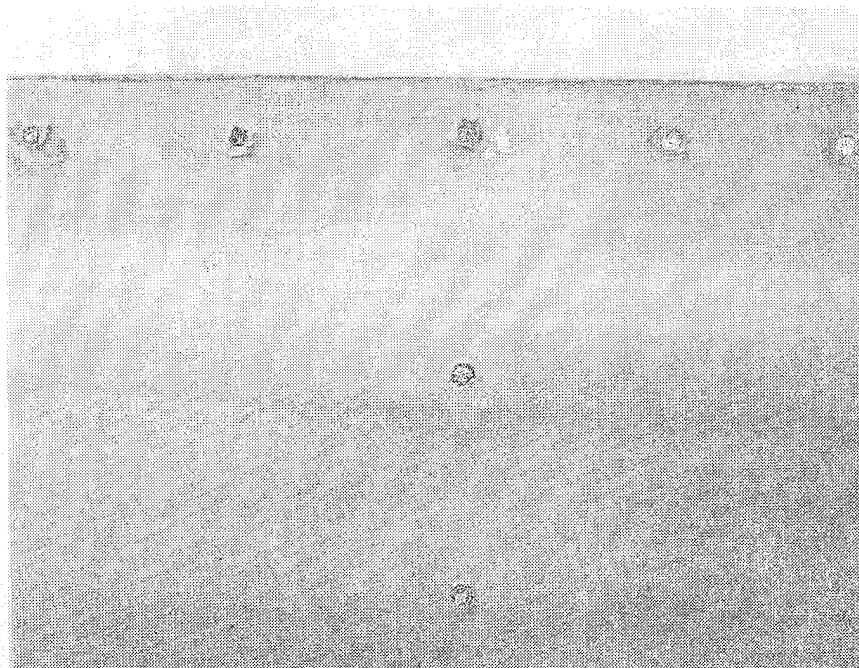
Figure 21. - Eastern right-hand aft engine fairing - fastener holes with moderate fraying.

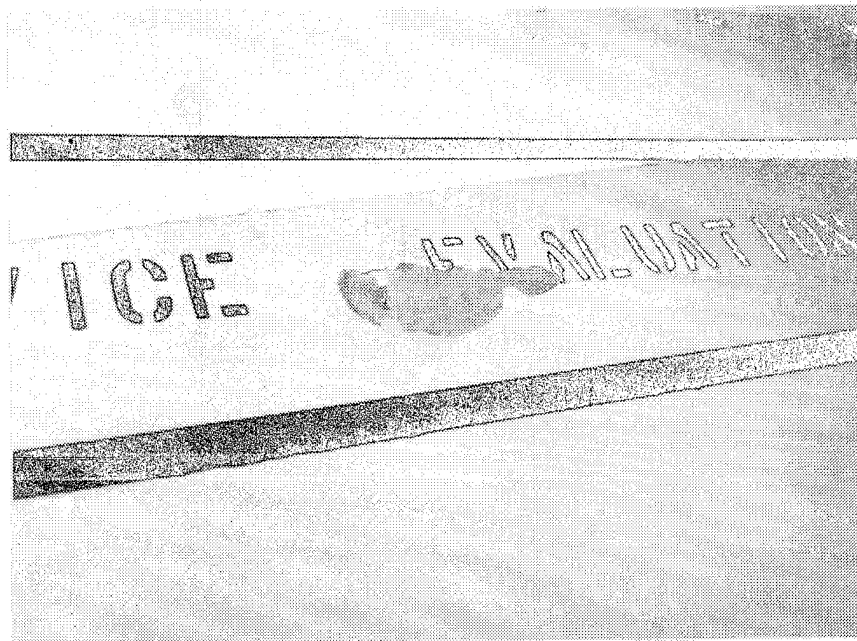
1. Two exterior surface defects observed in previous inspections had not increased in area. These were a deep gouge 1.3 cm ( $\frac{1}{2}$  in.) length in the upper forward area (Figure 22) with a disbond area extending forward of the gouge in a 1.3 cm ( $\frac{1}{2}$  in.) radius arc; and a small 0.3 cm ( $\frac{1}{8}$  in.) crack in the upper aft area, which had been painted over in the previous inspection. The crack was first observed in 1977, and the gouge was first observed in 1978.

Figure 22. - TWA left-hand wing-body fairing - 1.3 cm ( $\frac{1}{2}$  in) crack on exterior surface.

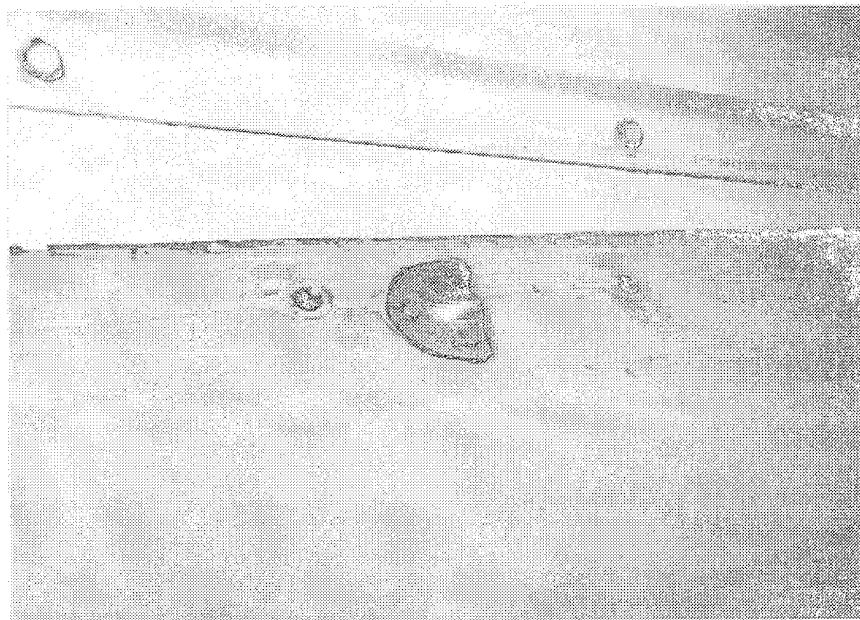
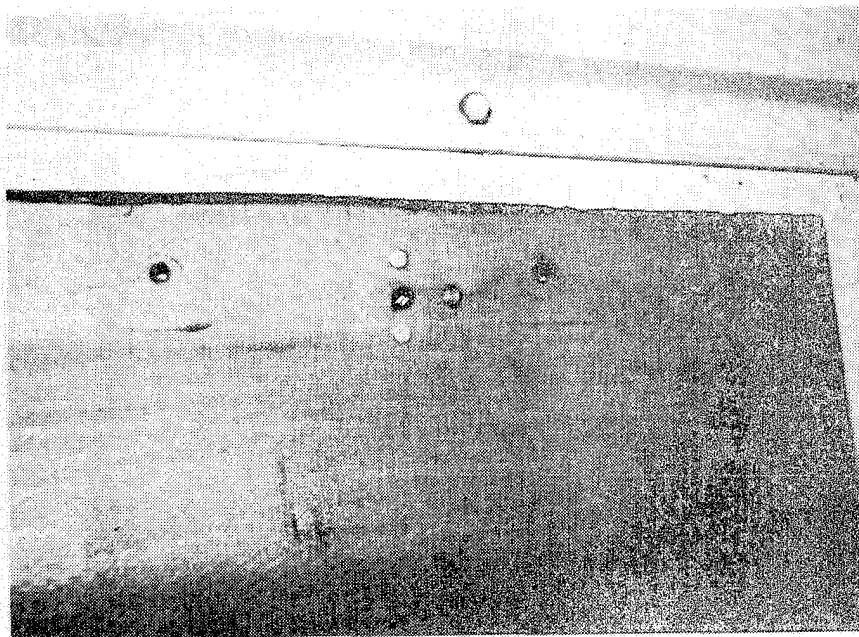
4. A bolted metal attachment covering a filled fastener hole was observed on the lower edge between the two aft holes. (Figures 23 and 24). When the panels were reinstalled, there was no record of hole relocation on the left-hand fairing

Figure 23. - TWA left-hand wing-body fairing - metal attachment from exterior.

Figure 24. - TWA left-hand wing-body fairing - metal attachment from interior.

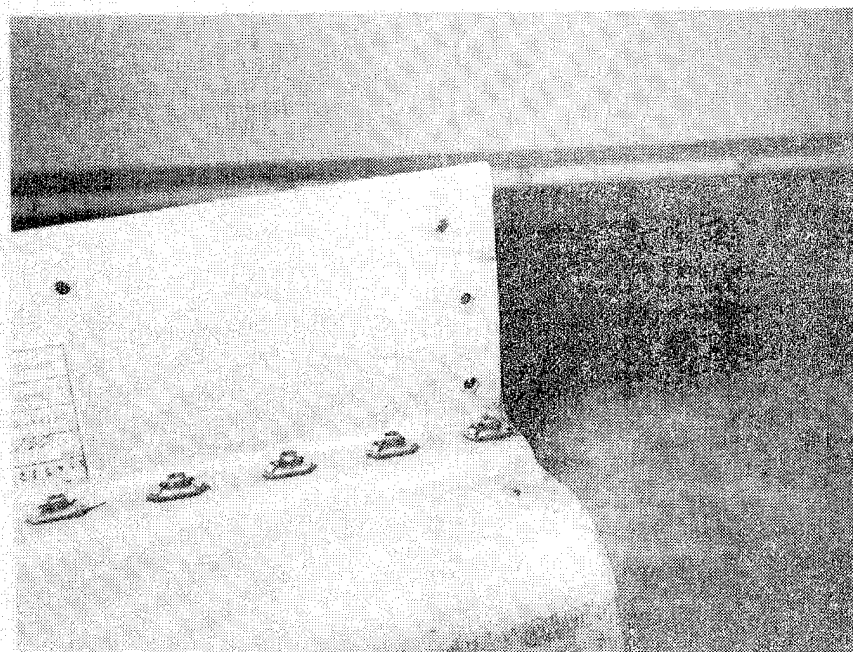
Figure 25. - TWA right-hand underwing fillet - fastener holes with frayed condition.

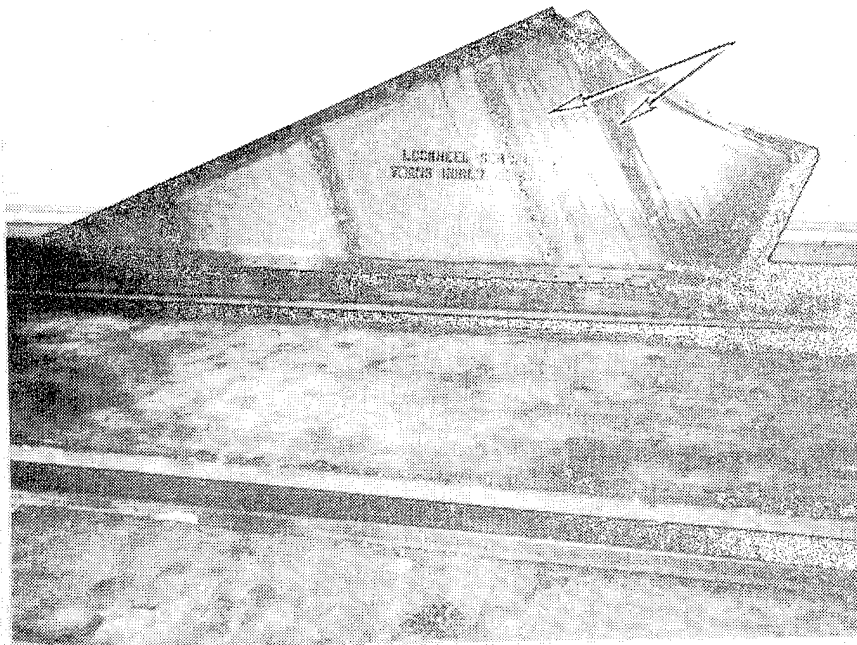
1. There was no damage to either surface. Loss of paint and flame spray had left some exposed Kevlar-49 surface. The vapor barrier coating, which had been applied to the inner surface during reinstallation to replace the Tedlar film, had been chemically attacked in several areas, probably by Skydrol. (Figure 26).

Figure 26. - TWA right-hand aft engine fairing - inner surface with vapor barrier coating showing chemical attack.

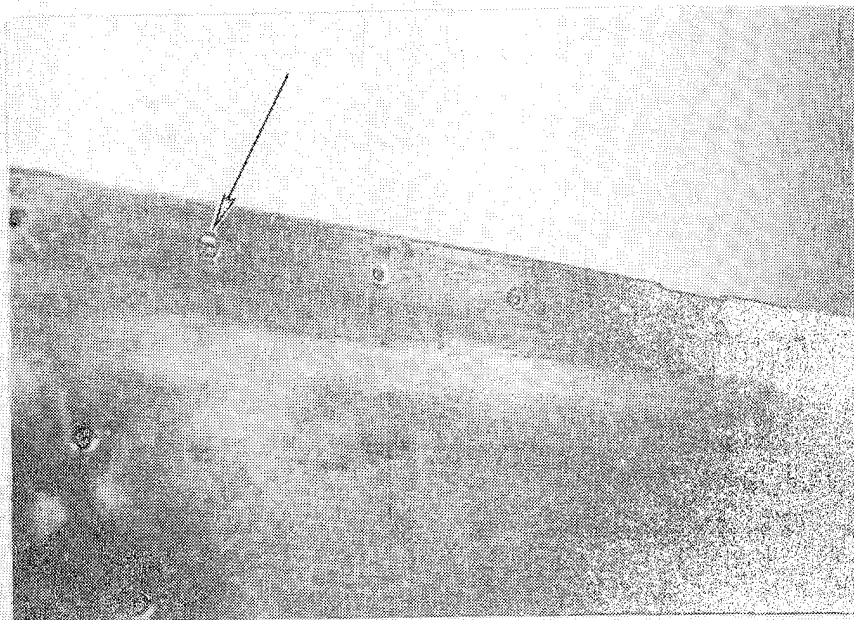
Figure 27. - TWA right-hand aft engine fairing - showing unfrayed fastener holes and an elongated hole.

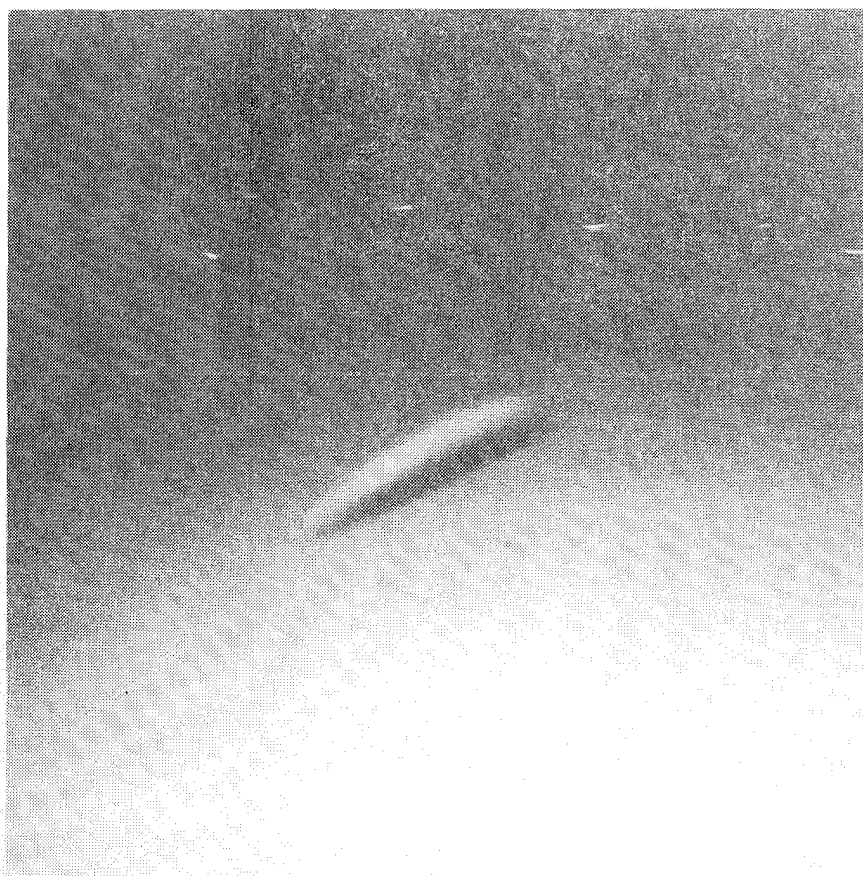
A different type of damage was initially observed in 1977 on the right-hand TWA wing-body fairing. This was a large teardrop shaped disbond area 11.4 by 2.5 cm (4.5 by 1 inch) in area with an associated deep concave depression indicative of core crushing. The paint and flame spray were intact with no cracks or crazing. This disbond has not increased in area or depth since the 1977 inspection. A similar but smaller disbonded and depressed area was initially observed in 1976, and has not grown since the 1977 inspection. These occurrences, which are unique to this particular fairing, are probably related to a repair made when the part was reinstalled on Ship 1111 (ref.3). This repair was not documented, but apparently consisted of replacement of a damaged core area, extending partially through the core thickness, with a microballoon-filled potting compound. This is not therefore a Kevlar-49-related problem, but as it is a highly visible condition it will be monitored in future inspections.

1. A large teardrop-shaped disbond and crushed area 11.4 by 2.5 cm ( $4\frac{1}{2}$  by 1 inch) first observed in 1977, was unchanged in appearance or extent. (Figure 28). This was in the lower forward area of the exterior surface. Another delamination in the lower forward area 5.1 by 1.3 cm (2 by  $\frac{1}{2}$  in.) first observed in 1976 had not increased in area since the 1977 inspection. A small crack 0.3 cm ( $\frac{1}{8}$  in.) also had not increased in length since first observed in 1976. No other damage was noted.

Figure 28. - TWA right-hand wing-body fairing -  
disbonded and crushed area on exterior.
